The Evaluation of Aluminum Foil-Interlayered High-Modulus K13CU Pitch Fiber-Siloxane- Modified Resin Composite Panels

15 July 2003

R. J. ZALDIVAR and R. CASTENEDA
Space Materials Laboratory
Laboratory Operations

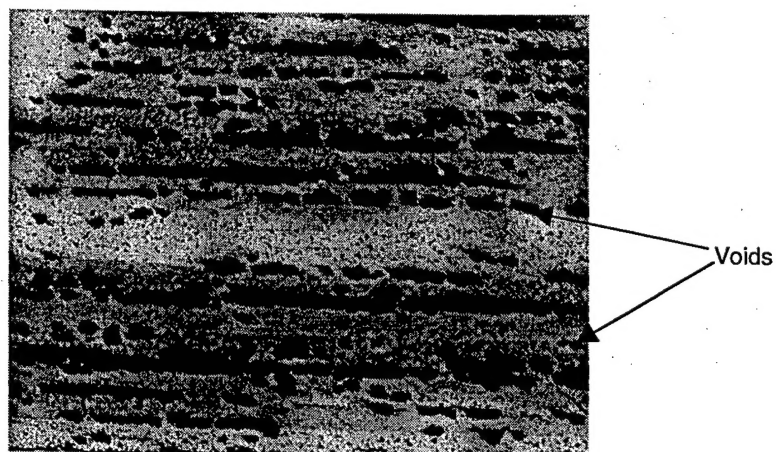
Optical microscopy of the initial lots of composite parts shown in Table 1 indicated that a high degree of interlayer porosity was located throughout the samples. Figures 2 and 3 show cross-sections of a typical K13CU laminate. The black areas in the micrograph represent areas of voids. The lighter areas of gray and white denote the matrix and fiber. As shown, there are substantial void areas oriented along the ply orientation. This is typical of a sample with poor resin flow characteristics and trapped volatiles. However, in this case, it may also be due to the nature of the materials used and the aluminum foil interlayer barrier as shown in Figure 3. As might be expected, the foil may behave as a barrier to the volatiles during cure. The mechanical properties of this composite would be severely degraded, especially in the matrix-dominated directions. A number of composite manufacturing trials were performed by the contractor to eliminate or reduce the porosity and improve consolidation. The set of samples shown in Table 2 were manufactured once the contractor optimized all of the processing issues.

Figure 2. Optical Micrograph showing midplane cross-section of K13CU laminate. Micrograph shows a large degree of interply porosity located between plies.

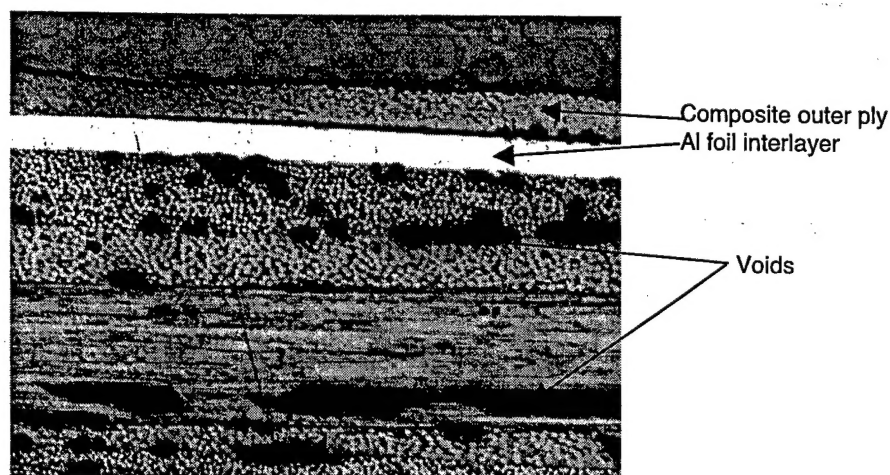
Figure 3. Optical Micrograph showing higher magnification cross-section of K13CU laminate with aluminum-foil interlayer at outer surface.

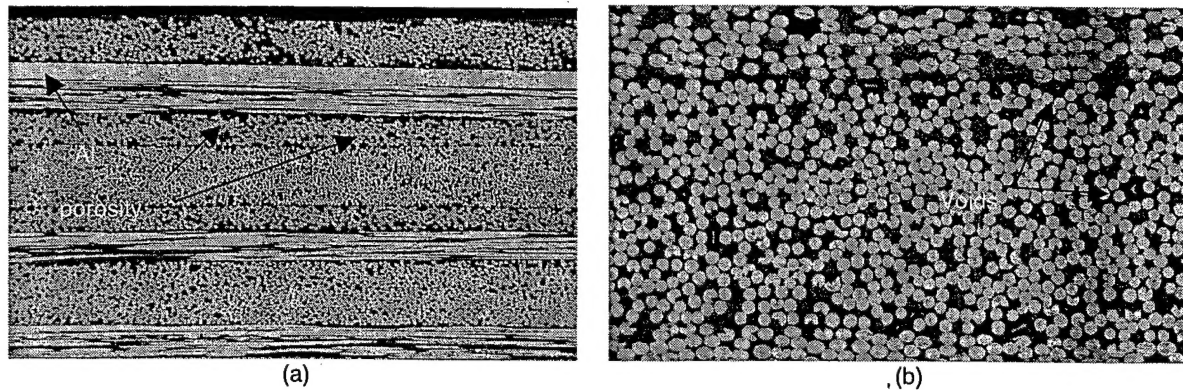
The aluminum-foil layer can be seen one ply in from the outer surface. Figure 4a shows this layer. The foil appears well bonded to both sides of neighboring laminate plies. Figure 5a shows a higher magnification photo of the aluminum foil within the structure of sample 1. No areas of debonding or excessive fiber-to-metal contact were

Figure 4. Cross-sectional optical micrograph of composite sample 1. The composite appears fairly well consolidated with some porosity observed within plies.

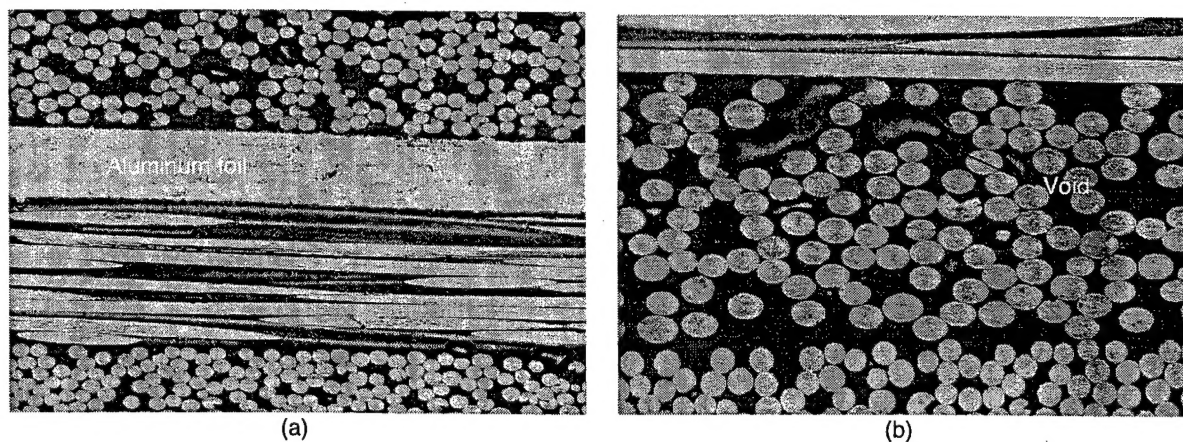
Figure 5. Cross-sectional optical micrograph of composite sample 1. (a) Shows good bonding on aluminum foil in the structure; (b) shows porosity within plies.

observed. Resin-lean areas would account for decreases in interlaminar shear strength; however, the sample appeared fairly resin rich on both sides. Figure 5b shows a higher magnification micrograph of the porosity observed within plies. The porosity appeared fairly well distributed throughout. Image analysis indicated a void volume of less than 2%.

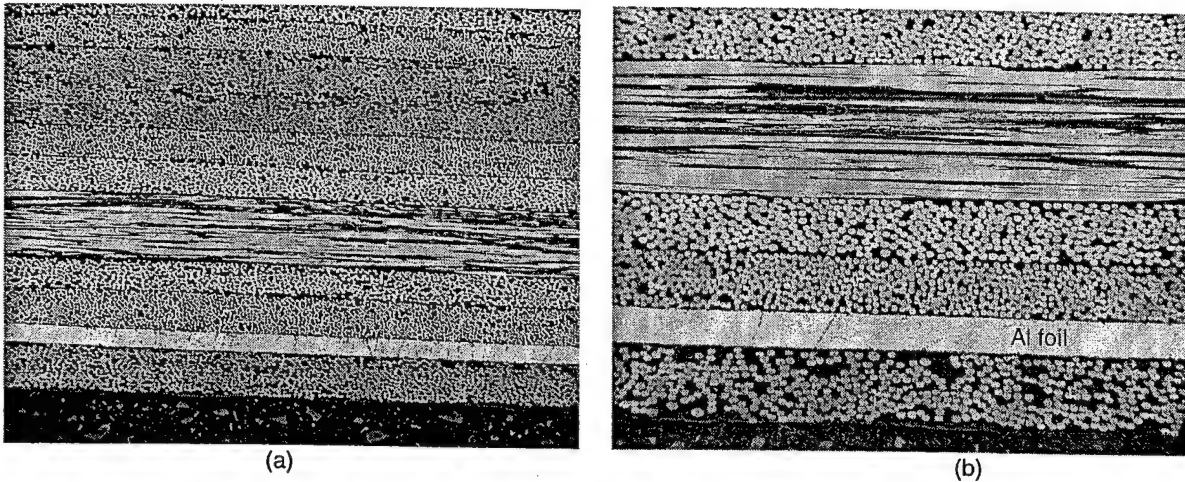
Figures 6 and 7 show cross-sections of sample 2. As shown, there appears to be consolidation and minimal porosity within the plies of this composite also. The aluminum-foil interface appears to be well bonded to the adjacent plies by the matrix material. No indications that would result in decreased mechanical properties were identified.

Figure 6. Cross-sectional optical micrograph of composite sample 2. (a) Shows good consolidation to aluminum foil in the structure; (b) shows low fiber content on outer ply.

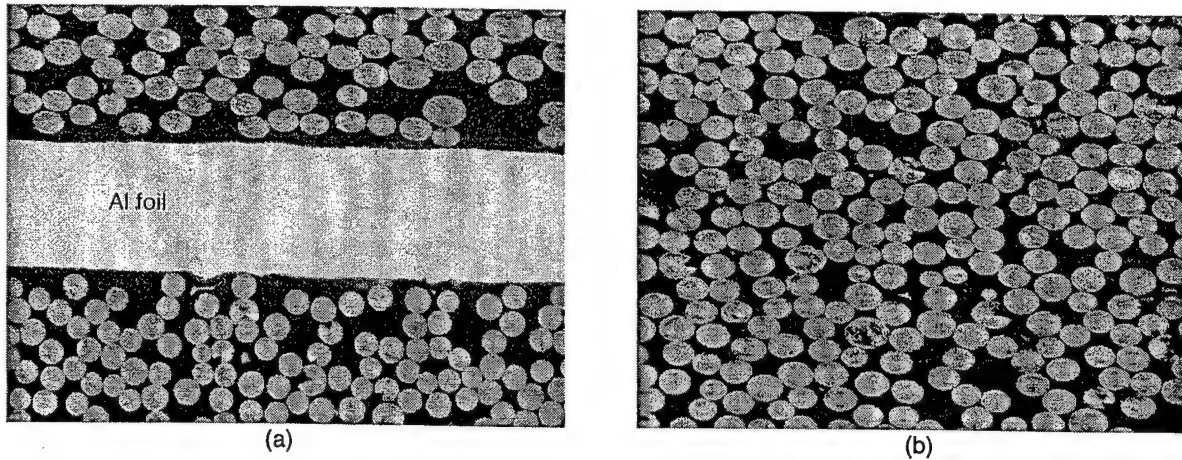
Figure 7. Cross-sectional optical micrograph of composite sample 2. (a) shows good bonding on aluminum foil in structure; (b) shows minimal porosity within plies.

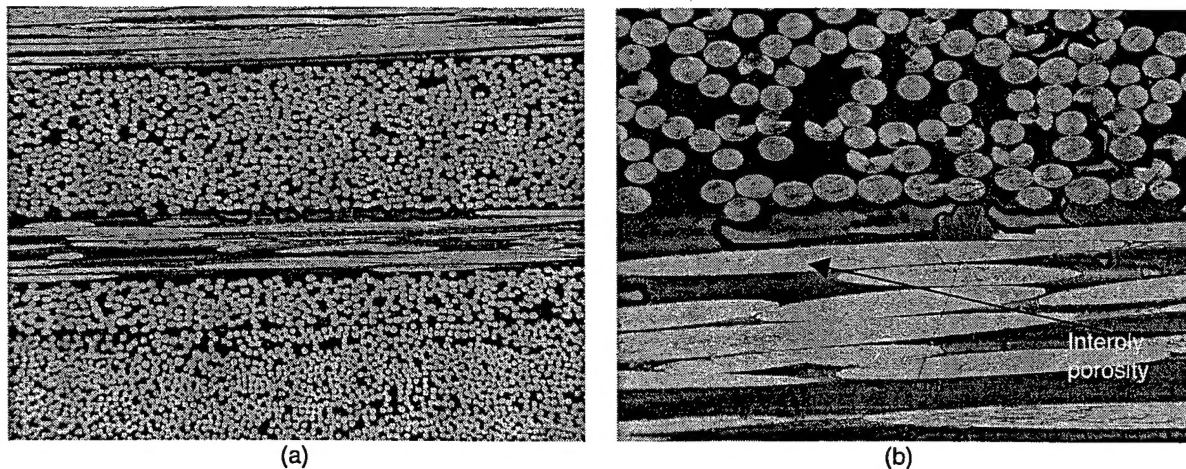
Optical micrographs of microstructural cross-sections of samples 3 and 4 are shown in Figures 8 and 9. Composite sample 3 appeared to have some pronounced porosity between the second and third ply. However, the porosity was limited to a fraction of the entire length of the sample. There were no indications of debonding between the foil layer and the adjacent prepreg. Composite sample 4 was notably different from the other specimens. Two aluminum layers were positioned in the mid-plane of the sample, in addition to the two foil layers closer to the sample surface. Sample 4 exhibited no other differences, which would raise cause for concern. Mechanical tests were then performed on the tag specimens to evaluate the failure mode.

Figure 8. Cross-sectional optical micrograph of composite sample 3. (a) shows good bonding on aluminum foil in the structure; (b) shows porosity within plies.

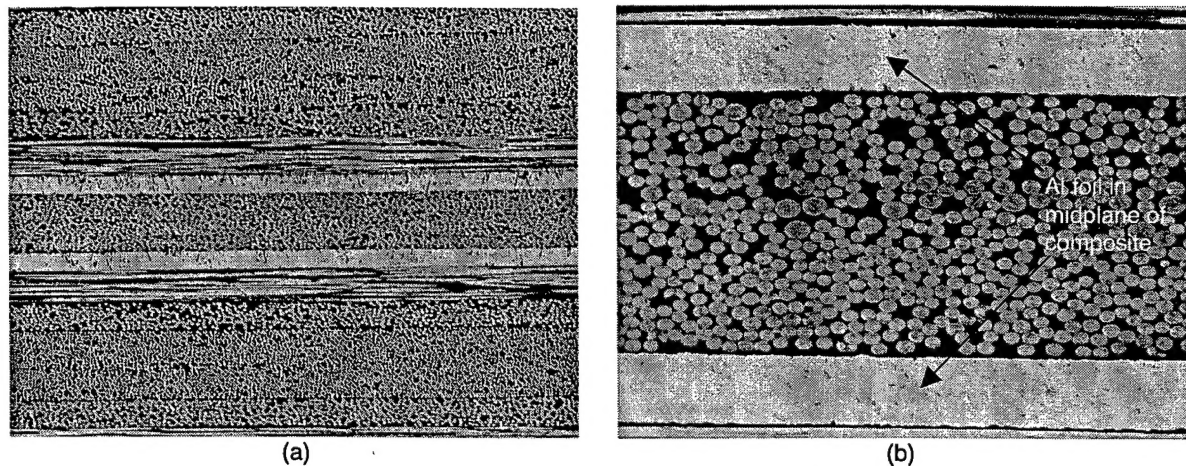
Figure 9. Micrograph of composite sample 4. (a) shows good bonding on aluminum foil in the structure; (b) shows minimal porosity within plies.

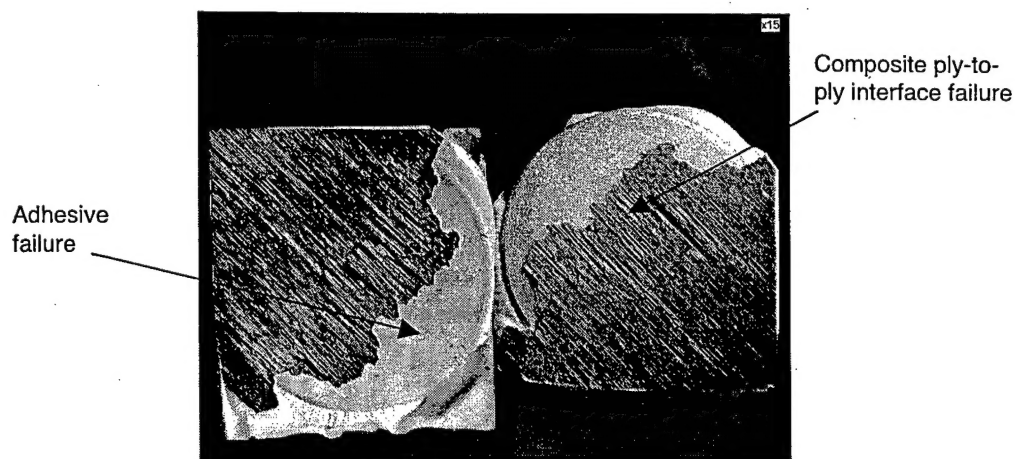
interply performance. The main reason for this testing was not to acquire mechanical strengths, but rather to determine where the failure was occurring. Figure 10 shows the fracture face for a typical flatwise tension specimen. This sample shows a mixed mode. Over 60% of the sample has failed within the composite, exhibiting a ply-to-ply separation. The majority of the failures occur within the first 3 outer plies. In this case, there appears to be some exposed metal from the aluminum plug. This indicates that some of the failure occurred at the interface between the aluminum plug and the bonding epoxy. An ideal sample failure would exhibit no such separation or adhesive failure. The failure load for this sample was somewhat decreased due to this separation. The other 3 specimens exhibited complete ply-to-ply separation.

Figure 10. Fracture surface of sample 1, 2, 3, and 4 all appeared to fail within the composite.

- Flatwise tensile samples of our composites were performed to verify the failure mode. Three of the four samples exhibited composite ply-to-ply failure as expected. One of the samples (H047PB004-005 S/N 001) exhibited a complete aluminum-foil interfacial failure. Additional testing of this sample is necessary to verify whether there is a need for concern.

All of the materials and processing issues appeared to be fine; therefore, the focus of the lower-than-expected strengths was placed on the test laboratory subcontractors specimen preparation procedure. The contractor was notified of our results, and we asked about the failure mode being experienced by the majority of the samples. Only one of our samples out of all of the lots exhibited an aluminum foil to composite separation. The subcontractor analyzed the failed samples and observed that the majority of the failures were actually occurring on the outer surface between the bonding adhesive and the composite face. This failure mode is usually indicative of poor sample preparation. Lower-than-expected strengths would be expected from this type of behavior. In order to improve the bond and get the correct type of failure mode, the composite sample needs to be roughened considerably to ensure a strong mechanical bond with the bonding adhesive. In addition, the type of high-modulus, pitch-based carbon fiber used in this composite is prone to weaker bonding than lower modulus PAN-based fiber typically used. The contractor instructed the testing laboratory in correct sample preparation, and, thus far, all of the composite test specimens appear to be failing within allowable ranges and within the composite.

- There appeared to be no issues dealing with the composite material investigated that would cause degradation in flatwise tension strengths. We suggest that the contractor investigate the sample preparation process that the laboratory testing subcontractor is using as well as verify the failure mode of all tested samples.
